Bendix Magneto Impuse coupling replacement

Steps to remove the impulse coupling.

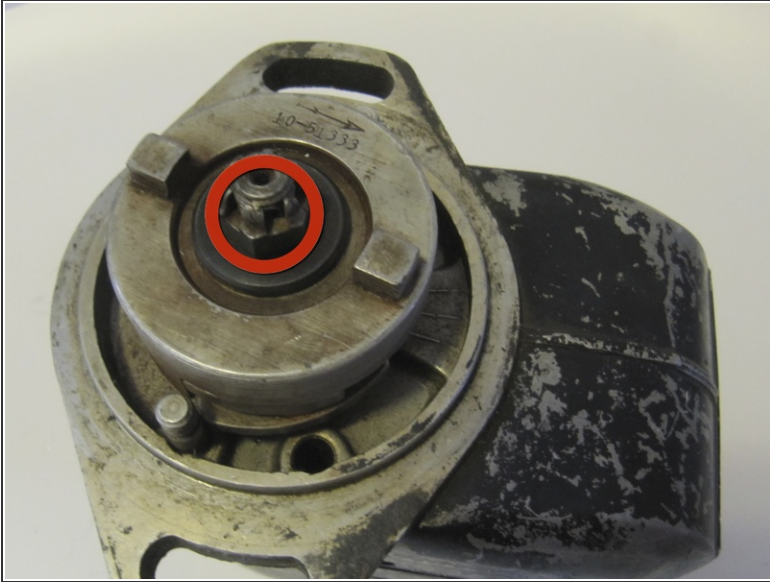
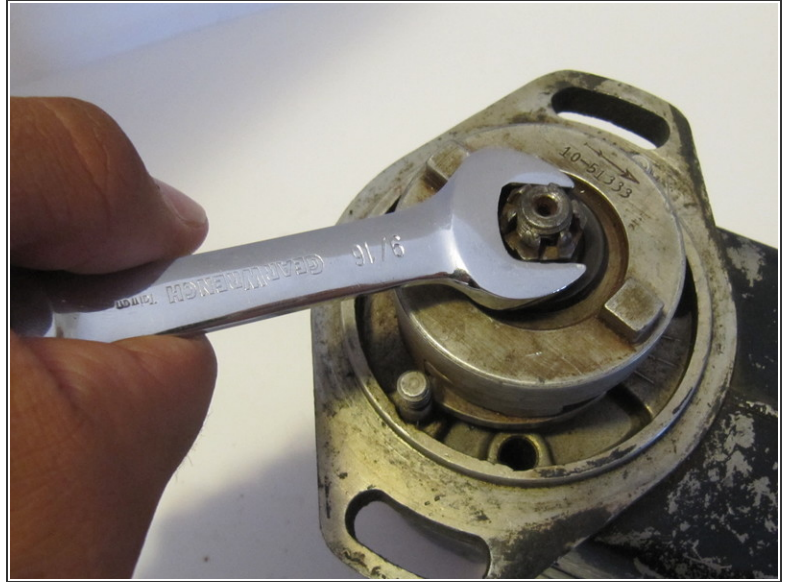
Step 1 — Impulse Coupling

- Use a 9/16 wrench to unscrew the nut on the drive shaft.
